# Exhibit D

**IN THE COURT OF COMMON PLEAS OF DELAWARE COUNTY, PA**  
**CIVIL ACTION - LAW**

**C. Exterior Façade/Cladding Defects throughout the Community**

Haverford Reserve  
Moisture Probe Testing  
Appendix A

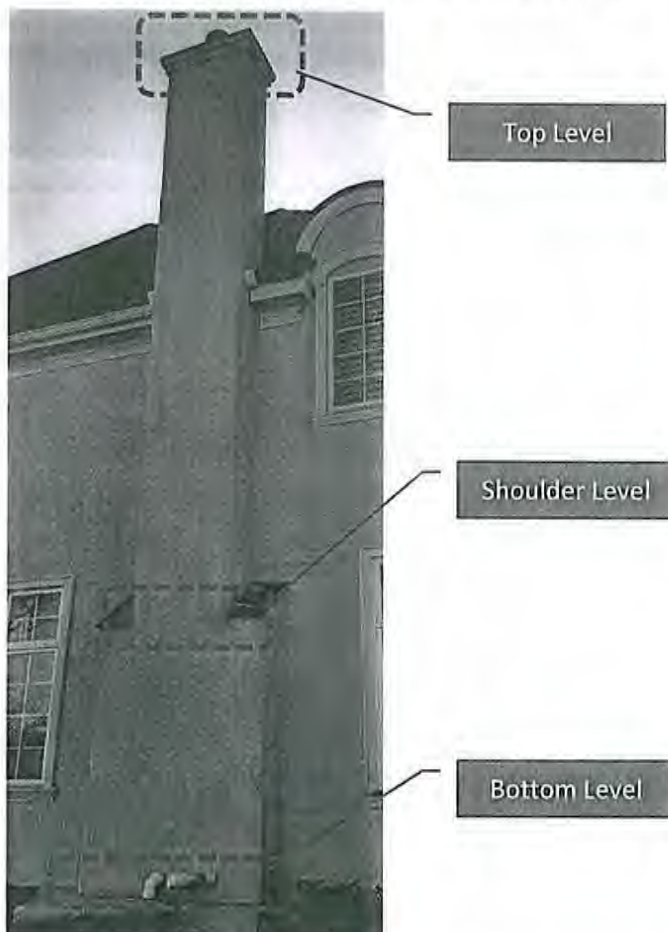
In general, moisture data was collected at three (3) 'levels' of each tested chimney enclosure. These levels are depicted in the figure below. The maximum moisture content measured at each 'level' are summarized in the table to the right of the figure.

Address	Top	Shoulder	Bottom	Year Built*
101 Green Lane	24%	13%	<b>38%</b>	2012
102 Green Lane	<b>32%</b>	29%	<b>39%</b>	2012
109 Green Lane	18%	37%	40%	2012
110 Green Lane	<b>31%</b>	28%	<b>40%</b>	2013
119 Green Lane	13%	<b>35%</b>	25%	2014
122 Green Lane	23%	10%	12%	2016
124 Green Lane	<b>23%</b>	<b>38%</b>	14%	2014
126 Green Lane	13%	10%	12%	2013
202 Valley Ridge Road	<b>40%</b>	10%	<b>11%</b>	2014
208 Valley Ridge Road	12%	12%	<b>40%</b>	2013
213 Valley Ridge Road	16%	<b>39%</b>	<b>40%</b>	2012
218 Valley Ridge Road	26%	12%	13%	2010
219 Valley Ridge Road	<b>22%</b>	37%	<b>15%</b>	2013
224 Valley Ridge Road	21%	13%	14%	2010
231 Valley Ridge Road	13%	8%	12%	2011
239 Valley Ridge Road	16%	<b>40%</b>	29%	2012
240 Valley Ridge Road	18%	12%	15%	2010
245 Valley Ridge Road	18%	<b>21%</b>	11%	2010
249 Valley Ridge Road	13%	<b>28%</b>	18%	2010
256 Valley Ridge Road	17%	<b>15%</b>	<b>40%</b>	2012

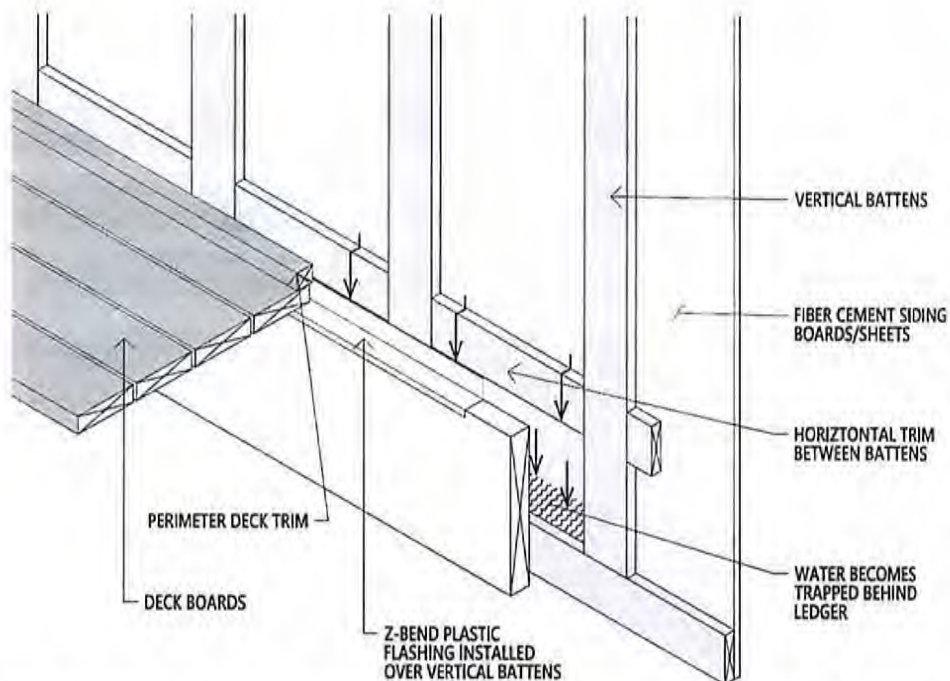
The existing construction contains a plastic 'z-bend' flashing component over the deck ledger. The upper vertical flange of this flashing is not properly integrated with the drainage plane of the wall. Instead, it is installed in front of the vertical battens of the siding system allowing water get behind it. Due to the lack of drainage provisions, this water can become trapped between the back side of the deck ledger and the face of the siding system. A graphical representation of this is provided below for clarification:

Fiber cement siding products are not permitted for structural use and will deteriorate when they remain in contact with standing water. This deterioration can have structural implications with the fiber cement siding being part of the structural connection for the deck ledger.

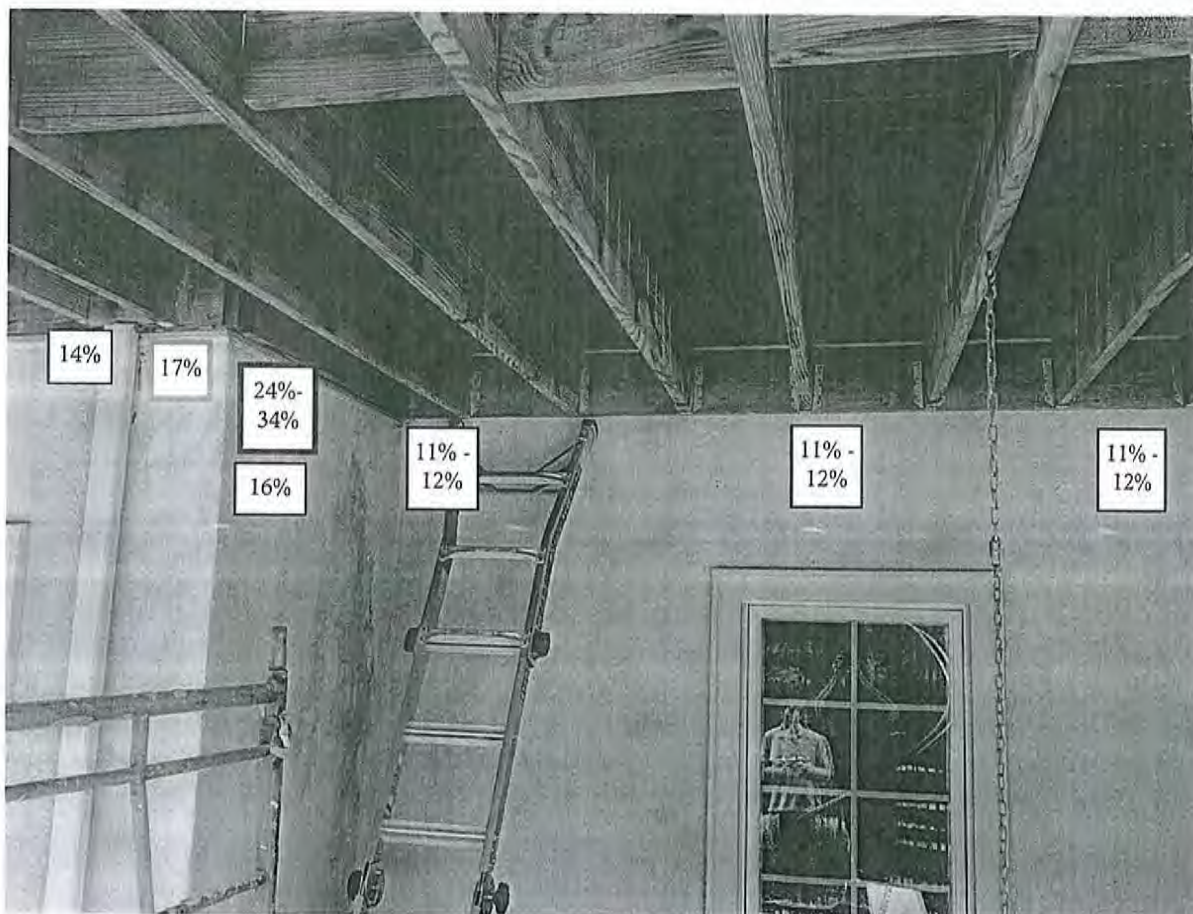
Moisture probe testing of the wood-based exterior sheathing was performed in multiple locations below the deck ledger. The figure below shows the approximate locations of moisture probe measurements. The moisture levels at the outside building corner below the deck ledger were as high as 34%, indicating moisture infiltration is active and occurring at levels where infection by wood rotting fungi will eventually occur and deterioration by wood rotting fungi can progress at a rapid rate. Moisture levels beyond the outside wall corner were within normal range (i.e. between 6.1% and 16.0%).

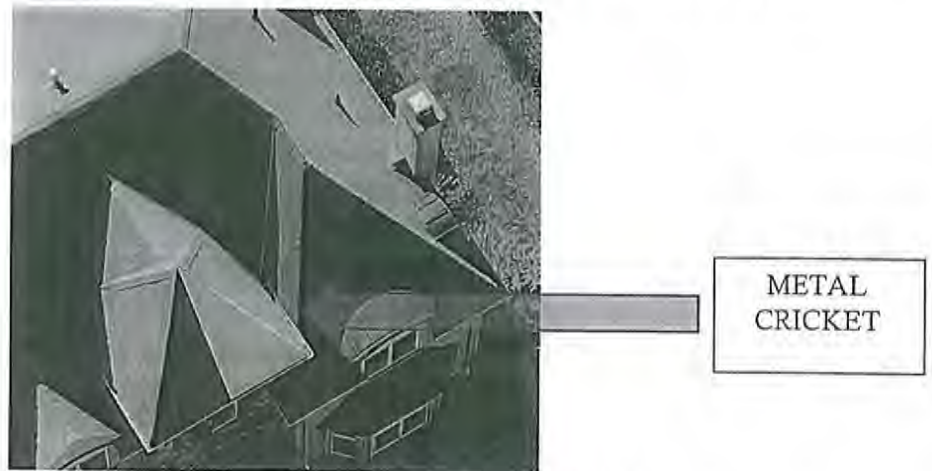
It should be noted that a number of issues pertaining to the 'tower' element of the Pembrey home models have been previously identified by Linn Architects. In general, the roof configuration of the Pembrey units causes drainage from a relatively large and steeply sloped roof area (see highlighted regions in Figure 11) to be funneled against the side wall of the tower element. This and other roof-related issues are documented in the June 2017 report by Linn Architects.

*Figure 11 – Aerial image of Pemby model roof; shaded areas represent portions of roof area that drain onto or along the side wall of the tower element.*
